**PRELIMINARY ASSESSMENT/
VISUAL SITE INSPECTION**

**GRM INDUSTRIES
WYOMING, MICHIGAN
MID 005 356 175**

FINAL REPORT

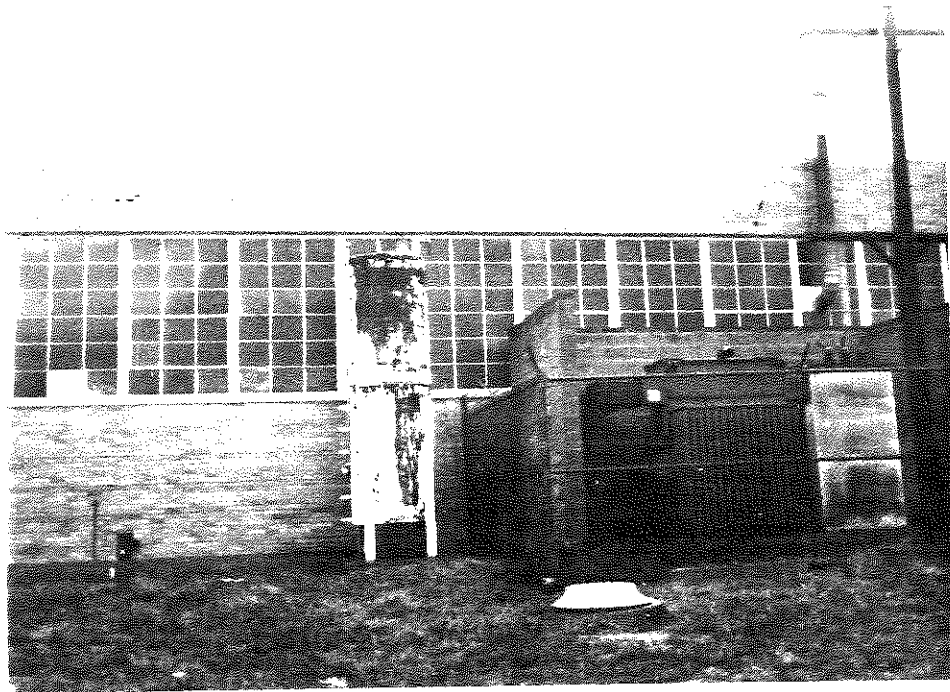
Location: SWMU #1
Date: 11-15-91

Observations: The exterior of the unit is rusty and deteriorating. No evidence of release was observed.

Conclusions: The past and possible current contents of this tank could not be determined. It may have contained degreaser solvent (F001) and/or strip solution (F009). Air contamination potential is low because chemicals are contained in a tank. Surface water contamination potential is low because all surface runoff is directed to a sanitary sewer. If the tank is full, it may soon rust out and its contents will leak directly onto the soil. The potential for contamination of the soil from the degreaser solvent tank is moderate due to the tank's poor condition and lack of secondary containment. Potential ground water contamination is low to moderate due to the presence of sand and gravel in the soil and the proximity of depth to ground water (15 to 20 feet below grade).

Photograph No. 1
Orientation: East
Description: Degreaser Solvent Tank

Recommendations: The tank should be emptied and removed, consistent with MDNR and EPA requirements.

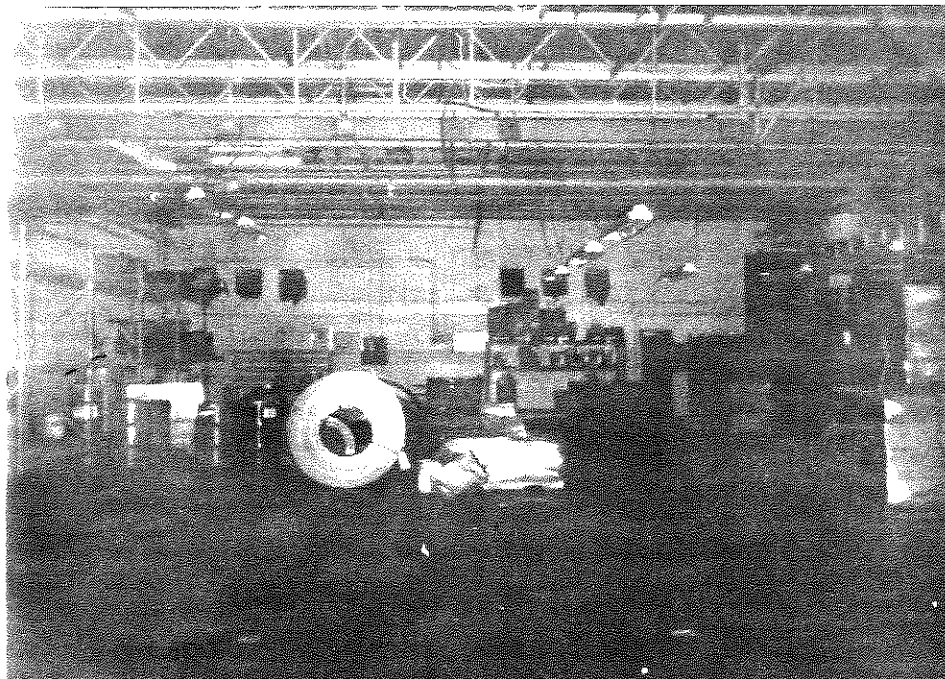
Location: SWMU #2
Date: 11-15-91

Observations: During the VSI this unit contained product materials including sheet steel, and several drums with unknown contents. Facility personnel did not provide further information requested regarding drum contents or storage of hazardous wastes in this unit. The concrete pad was clean and appeared to be in sound condition, and no floor drains were noted within or near this unit. No evidence of release was observed.

Photograph No. 2
Orientation: East
Description: Drum Storage Room

Recommendation: The area should be inspected to ensure that drums were removed consistent with RCRA regulations. If drums are present, contents should be characterized, and the drums removed.

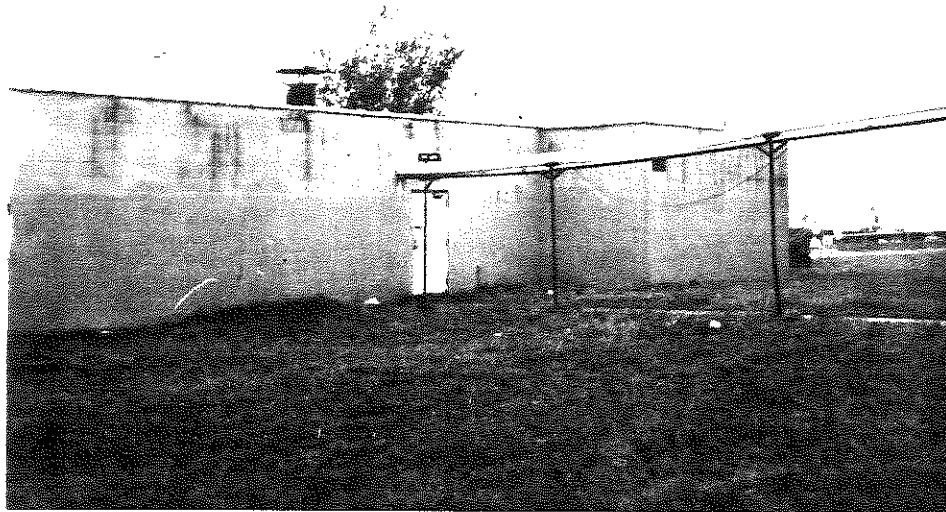
Location: SWMU #3 -
 Date: 11-15-91

During the VSI the waste water treatment plant's interior process area was inaccessible and could not be viewed. The trench drain was covered with sheet metal, but appeared to be made of concrete. Facility personnel could not offer any details regarding the status of the unit. The exterior was in a shabby but not deteriorating condition. No evidence of a release was noted in the soil surrounding the unit.

Photograph No. 3
 Orientation: Northwest
 Description: Waste Water Treatment Plant

Recommendations: Clean the unit, consistent with MDNR and EPA requirements. Further soil sampling near the trench drain should be conducted.

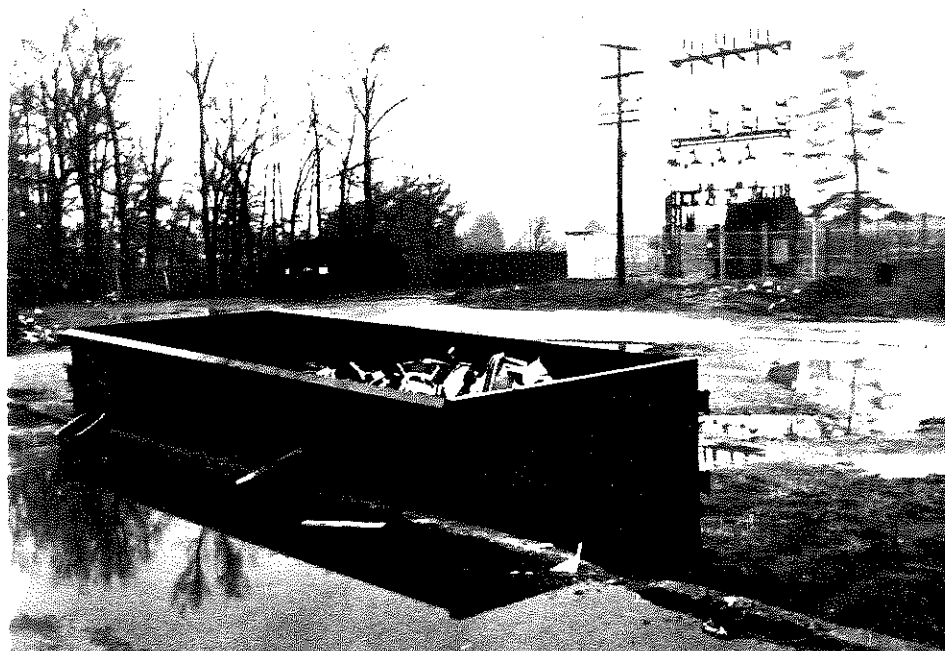
Location: SWMU #4
 Date: 11-15-91

Two of the steel dumpsters are located on a concrete slab. The other two are located on the unprotected ground. No other release controls were noted.

In February 1989, a RCRA compliance inspection by the MDNR, noting a scrap metal dumpster leaking oil onto adjacent soils. The report stated that the affected soil must be removed and the area modified to ensure that similar future incidents would not occur (MDNR, 1989). Records indicate that the violations noted in the February 1989 inspection were corrected; however, the details of these corrections could not be found.

Photograph No. 4
 Orientation: Southwest
 Description: Scrap Metal Dumpster Roll-Off located west of Main Building. Ponded rainwater is on ground and in concrete foundation in foreground.

Recommendations: Sample the ground water in the vicinity to determine if any contamination exists. Sample the nearby soil to delineate the extent of soil contamination. The area should then be remediated to remove all oil contamination.

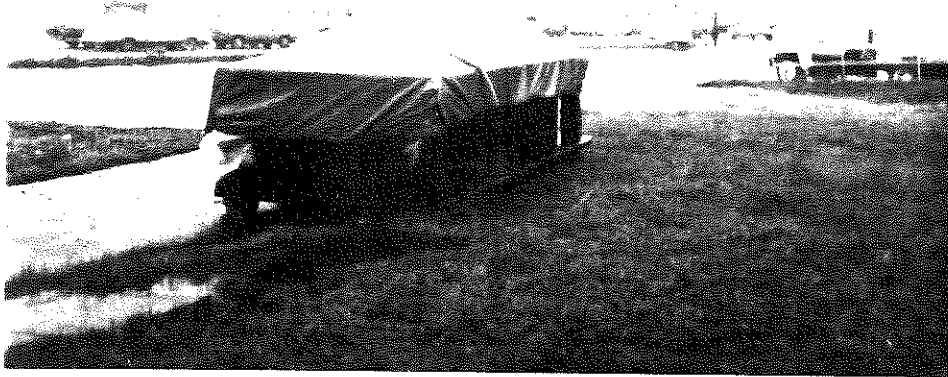
Location: SWMU #5
Date: 11-15-91

Observations: The dumpster was full of dewatered sludge and was covered with a tarp to protect it from rain. Based on the October 31, 1991, RCRA compliance inspection, this dumpster has been onsite for more than 90 days. The unit appeared to be in sound condition. No visible evidence of release was observed.

Conclusions: Because the dumpster appears to be in good condition and covered with a tarp, the potential for release to air, surface water, and groundwater is low. The potential for impacted soil beneath the dumpster is moderate due to possible leaching of contamination onto the unprotected ground.

Photograph No. 5
Orientation: North
Description: Chrome Sludge Dumpster

Recommendations: The dumpster, filled with waste, has been on-site for more than 90 days. Therefore, this unit must undergo RCRA closure, which includes sampling of the soil.

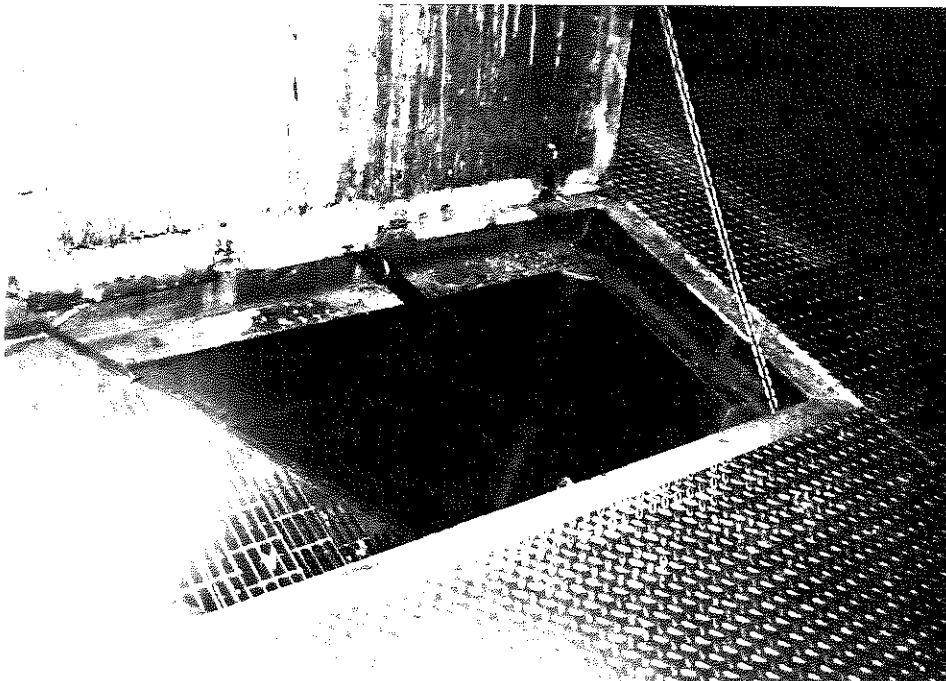
Location: SWMU #6
Date: 11-15-91

Conclusions: Because the pits are located beneath the concrete floor in the main building, air and surface water contamination potential is low. Information regarding the condition of the pits or their release controls could not be obtained; therefore, potential for groundwater and soil contamination could not be assessed.

Photograph No. 6
Orientation: Northwest
Description: Waste Oil Pits

Recommendation: The integrity of the pits should be determined and the pits should be cleaned.

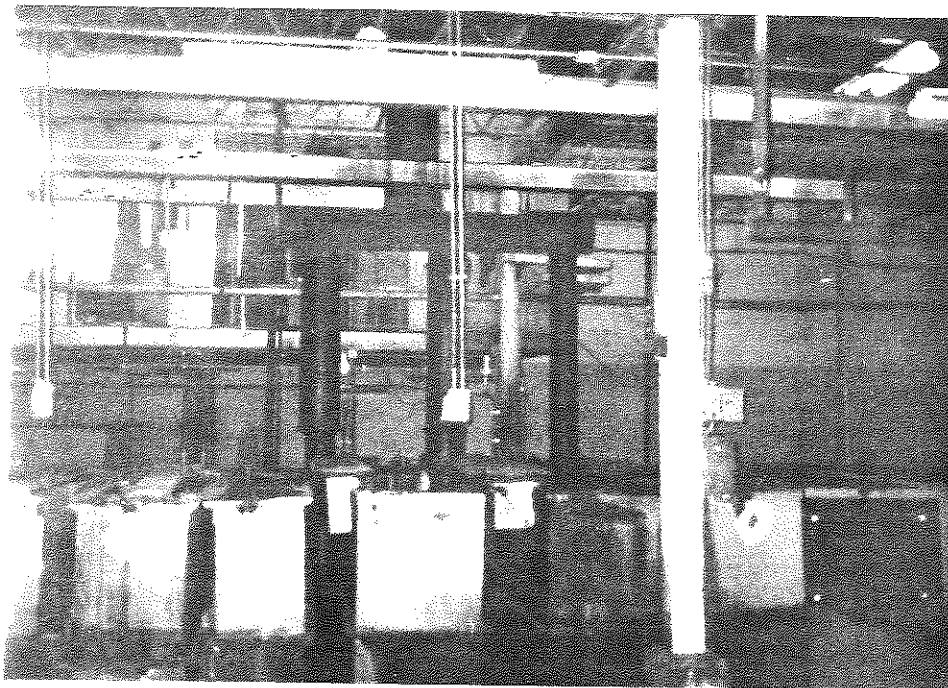
Location: SWMU #7
Date: 11-15-91

Photograph No. 7
Orientation: East
Description: Air Scrubber

Recommendation: No further action is suggested.

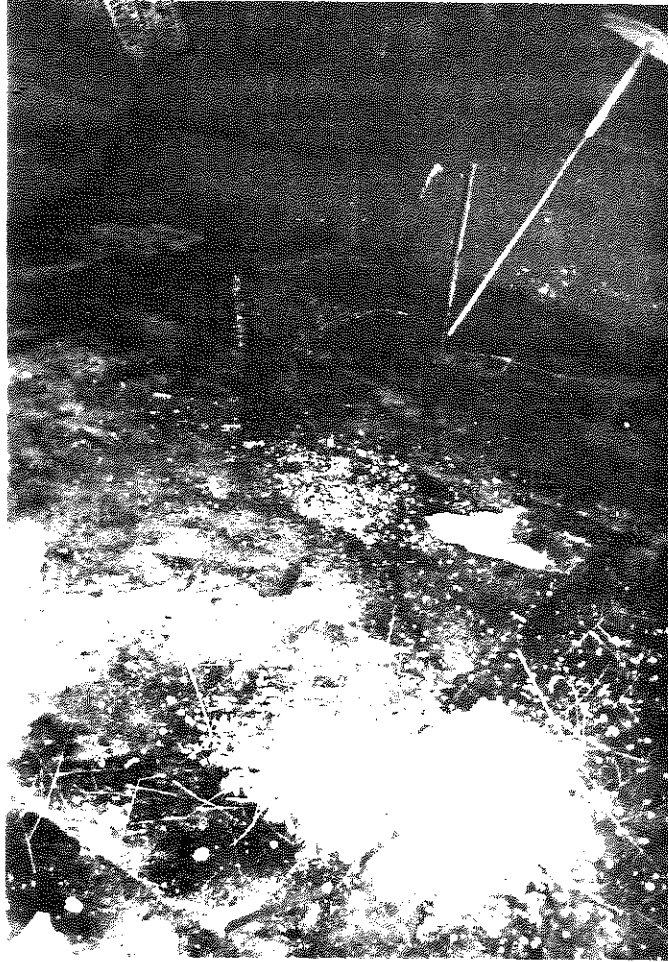
Location: SWMU #8
Date: 11-15-91

generated. The floor is concrete. Since the pit was imbedded in the floor, only the top two feet by two feet opening could be observed (Photo 8).

Observations: The whole area was covered with a thick, black oily substance and miscellaneous metal scraps. The pit appeared to contain some waste oil/water mixture. The unit is below the floor surface and, as such, the condition of the concrete, etc. could not be observed.

Conclusions: Air contamination potential is low because the unit is contained in an enclosed section of the main building and the materials are of low volatility. Surface water contamination potential is low because all surface water runoff is routed to the sanitary or storm sewers. Information regarding the condition of the pit and its release controls could not be obtained; therefore, potential for release to the groundwater and soil could not be assessed.

Photograph No. 8
Orientation: South
Description: Waste Oil/Water Pit

Recommendations: The pit and surrounding area should first be inspected and integrity-tested and then cleaned before GRM Industries leaves the facility.

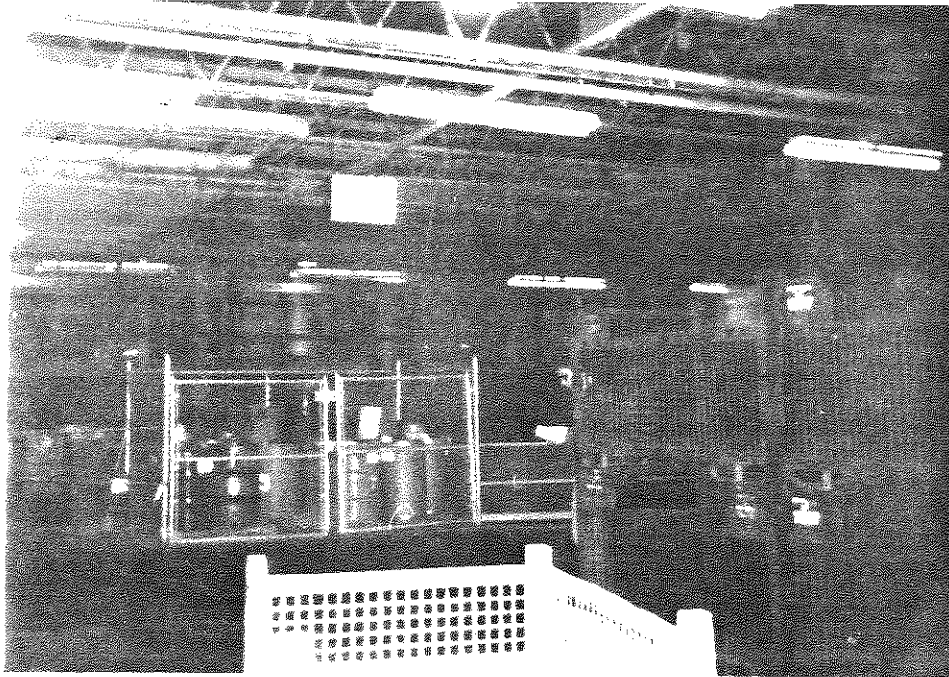
Location: SWMU #9
Date: 11-15-91

Observations: Both areas were clean and no visible evidence of release was observed. Three drums were present in the western area and approximately ten drums were present in the eastern area. Information regarding the contents of the drums was not provided by facility personnel, but they believed them to contain product. No floor drains were noted within or near these areas.

Photograph No. 9
Orientation: East
Description: Additional Drum Storage Areas

Recommendation: The area should be inspected to ensure that drums were removed consistent with RCRA regulations. If drums are present, contents should be characterized, and the drums removed.
